Property Condition Assessment

85 Lake Hill Road
Burnt Hills, NY

Inspection Date: April 17, 2013

Inspected by: Foresight Architects
426 State Street, Schenectady, NY 12305
Inspectors: James Hundt, RA & Ted Lutz, RA
Phone: (518) 372-3655

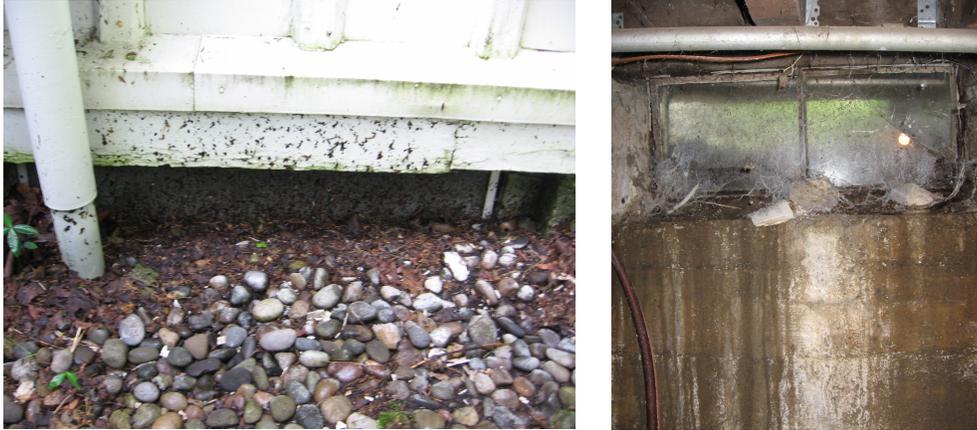
Foundations/Walls: The foundation walls vary, depending upon the date of construction. The foundation walls of the 19th century construction consist of uncoursed stone walls. On the south and west sides of the building, these foundation walls are not visible for inspection from either the interior or exterior. Only the north side has visible stone foundation walls. There are windows and vents into the crawlspace. Although the exterior grade is generally sloped away from the foundation and the crawlspace is extremely dry with no evidence of moisture infiltration through the ground, in two locations, the grade is above the bottom of the opening. This is the cause of the leaking near the electrical panel in the basement.

Exterior and interior views of a basement window with sill below grade

Recommendations	Costs	Time Frame
1. Replace windows and vents that go below grade with shorter windows and vents.	< \$3,000	Immediate
2. Repair and repoint original foundation wall.	< \$3,000	Short term

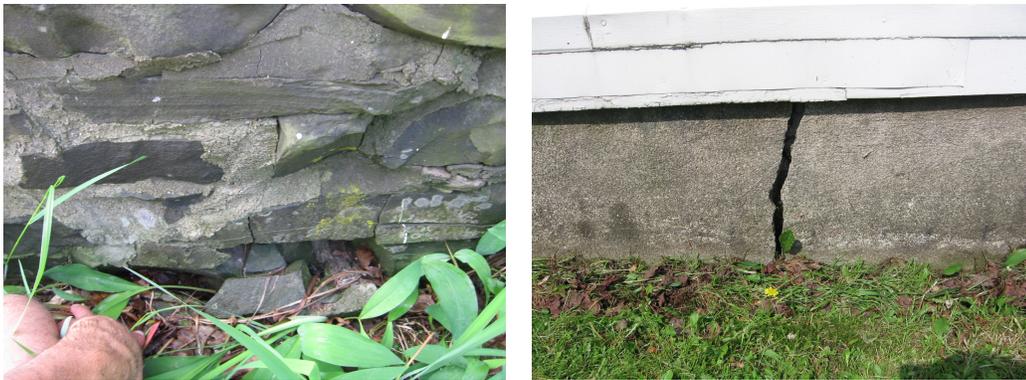
There has been repair work done on the eastern end of this foundation in the past. It appears that, as part of the repointing, mortar or concrete was placed between the foundation wall and the earth, creating a sort of shelf at that point in the wall. Much of this “shelf” has deteriorated and areas below this shelf are in need of repointing. There is also a large crack in the north wind, along the east wall, which might be due to settlement. There was a crack on the western side, but it was much smaller. The crawlspace under this wing is inaccessible for inspection.

Original foundation wall and crack in repaired original foundation wall

3. Caulk cracks in north wing foundation wall and monitor for further movement.	< \$3,000	Immediate
4. Replace wood skirt & sills with cellular PVC	\$9,000-15,000	Short term

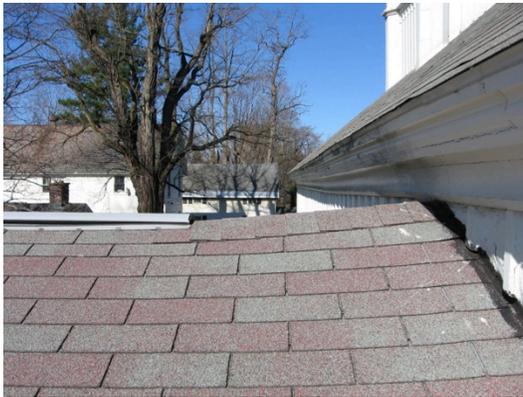
The structure for the transept roofs was not visible. Both structures showed noticeable sagging of the ridge at the center as well as cracks in the ceiling below. The ceilings in the transepts are pitched, which means that there are no continuous structural members resisting the horizontal thrust of the roof rafters. This condition often results in sagging of the center portion of the roof, especially if the roof had a heavy dead load, such as slate shingles. It is likely that this movement dates from some earlier period of time. To fully assess this situation, access to the roof structure needs to be provided. The easiest way to do this would be to remove some of the sheathing the next time the roof is replaced to inspect the conditions at the ridge and at the eaves.

Sagging Ridge at South Transept

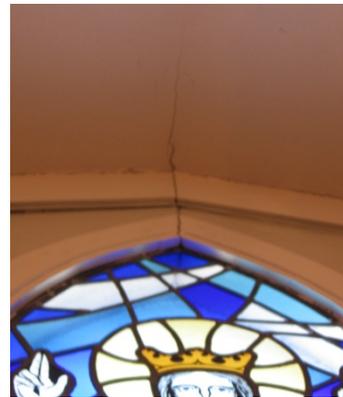
Interior Crack at Ridge of North Transept

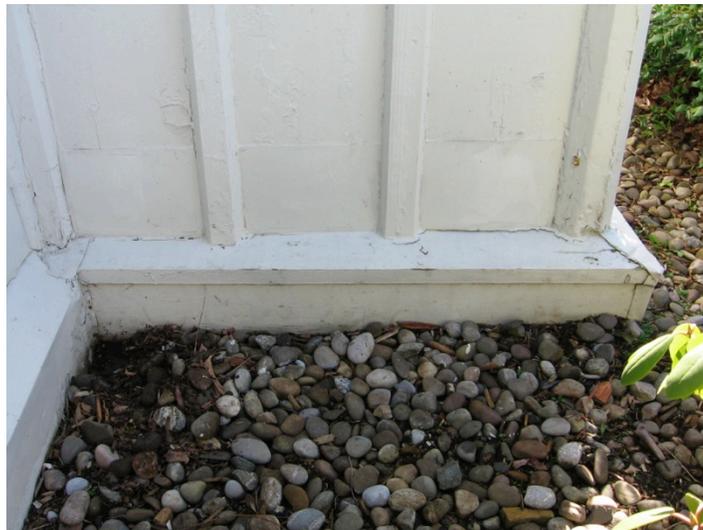
- Sidewall System: The exterior walls consist of a wood board and batten systems throughout. In the later construction, it appears that plywood was used for the boards. The exact nature of the boards on the rest of the building could not be determined without creating an opening in the exterior wall. For reasons unknown, the top of foundation walls of this building are very close to grade on the south side of the building which means that the wood sidewall system ends at or, in some cases, below finished grade. This makes the wood skirt of the building particularly susceptible to deterioration due to excessive moisture. The skirt is capped by a wood sill with minimal pitch, upon which rest the boards and battens. This sill probably collects snow in the winter, either on the sill itself or from buildup of ground snow. This condition causes deterioration in both the sill and the boards and battens. In some locations, the sill and skirt have been covered with aluminum. In some locations, the boards have been covered with sheets of aluminum glued over the deteriorated wood. In other cases, boards or battens have been replaced with new wood pieces.

5. Repair or replace rotted boards & battens	\$1,000	Short term
6. Remove protective glazing from stained glass windows and repair & repaint windows as required	\$8,000-12,000	Immediate

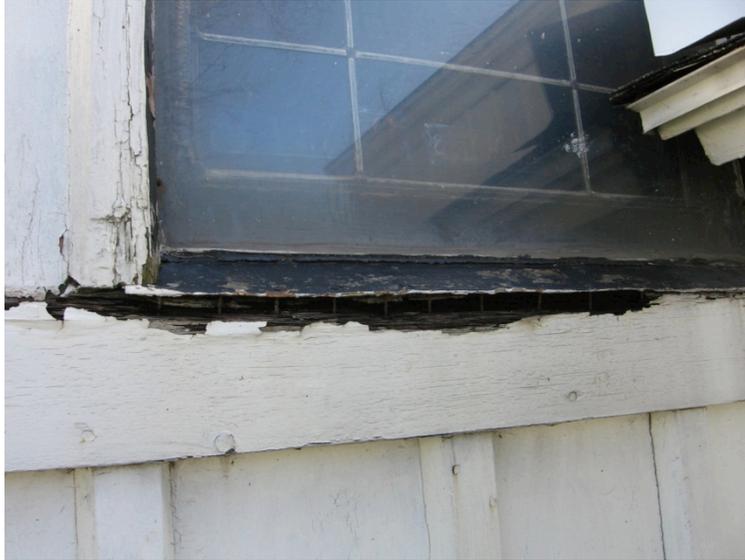
The detailing for the windowsills is to run them straight into a horizontal batten relying solely on a caulk joint to prevent water from getting behind the batten. As this caulk joint fails, water is able to get into the sill and deteriorate the sill.

Deteriorated Windowsill

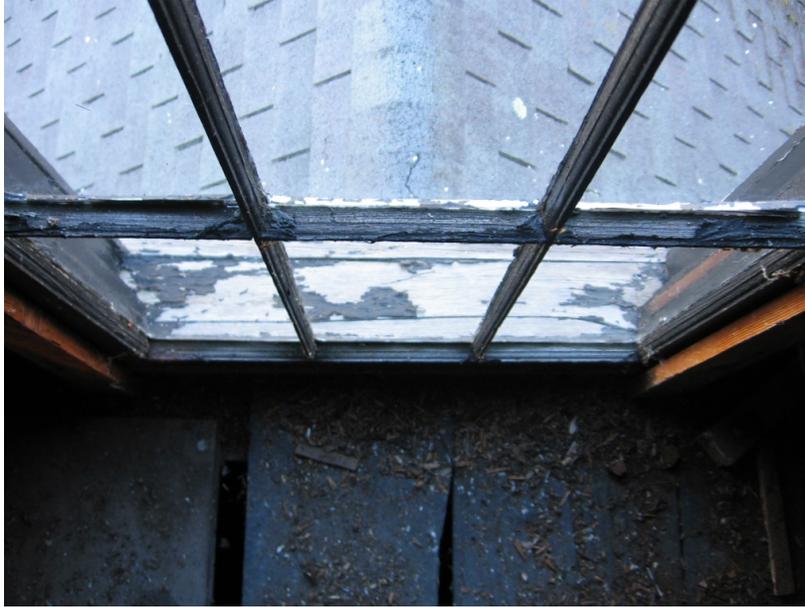
Deteriorated Tower Window and Windowsill

The paint on the casement windows is not in very good condition. The window in the tower is severely deteriorated, especially the muntins, and should be restored or replaced.

7. Repair damaged stained glass windows	\$15,000-20,000	Short term
8. Replace deteriorated windows in bell tower	\$2,500-3,000	Immediate
9. Replace casement windows in Sacristy addition	\$5,000-7,500	Short term

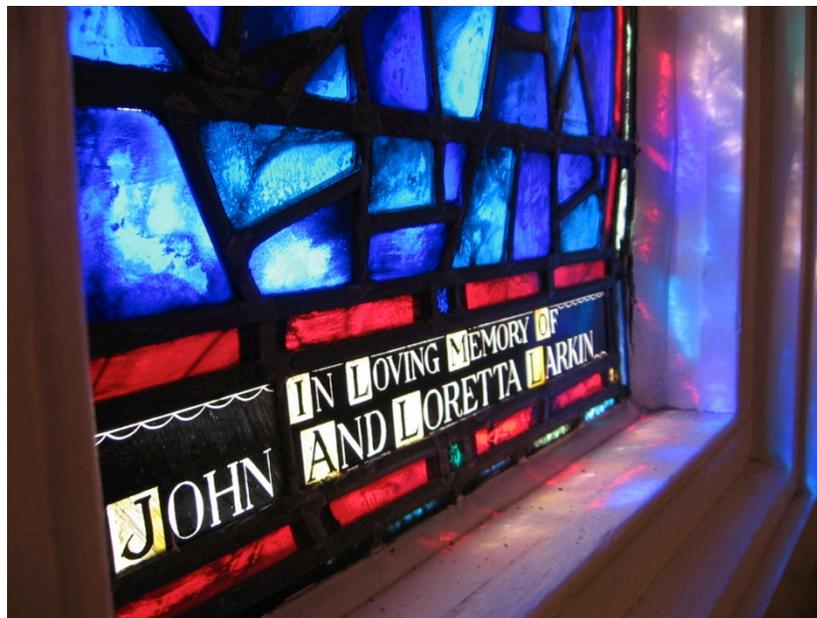
up between the protective glazing and the stained glass window, which often leads to premature failure of the window due to softening lead and sagging glass. This kind of damage is evident in at least one window on the south side of the building.

Bowed Stained Glass Window

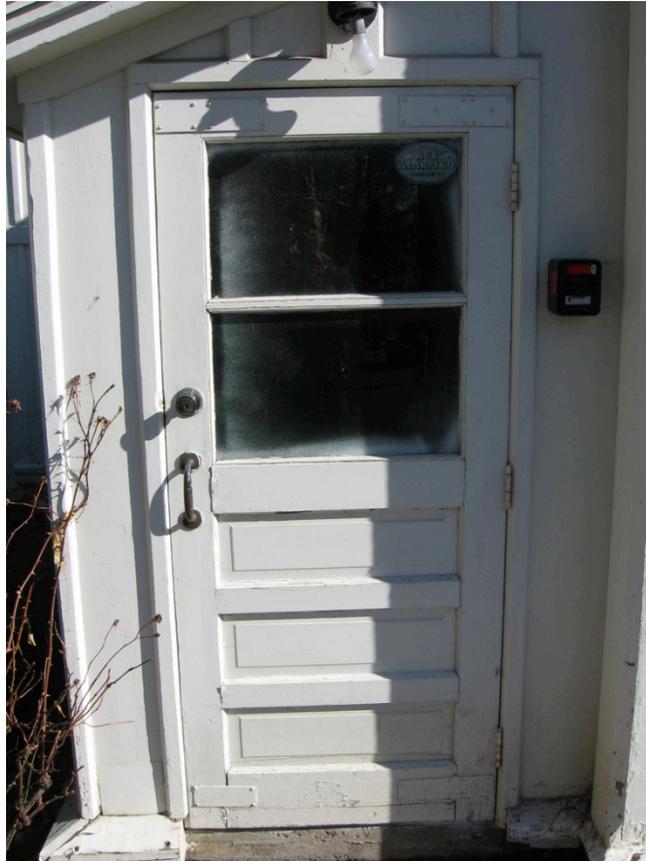
- Exterior Sealants: As mentioned earlier, the sealant at the bottom of the stained glass window sills has failed in some areas.
- Exterior Doors: All exterior doors are wood. The main entrance door is in good condition. The door to the Sacristy has started to delaminate at the bottom. Since this door is protected from rain and snow by a covered porch, it should be repaired rather than replaced. The door to the basement stair is being held together with metal mending plates and should be replaced.

Door to Basement Stair

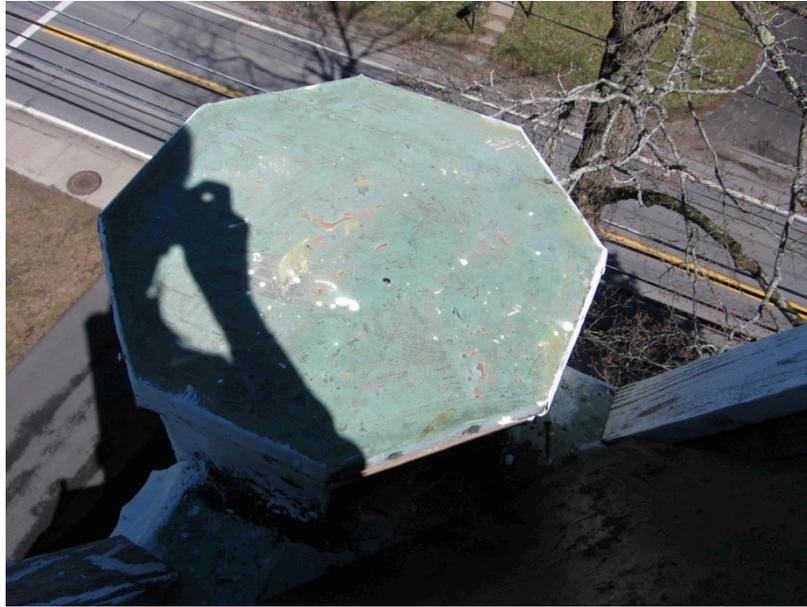
- Bell Tower: In addition to the typical board & batten siding, the bell tower also incorporates various wood details, including octagonal columns at each of the four corners of the tower. These columns terminate at the base of the valleys of the tower roof, which consists of two gable roofs intersecting each other, creating four valleys. The tops of these columns are covered in copper. We inspected the northwest column that was accessible from the tower roof hatch and found it to be in good condition. The columns themselves and the walls of the bell tower show various signs of failure, including splitting boards and falling trim. There has been a persistent leak through the ceiling above the interior doors to the Sanctuary. Evidence after a heavy rain event indicates that the water is entering through the deteriorated windowsill and through cracks between the boards. Since both the copper cap and the flashing at the roof at

Copper Cap on Bell Tower Column

10. Repair or replace wood on bell tower	\$12,000-18,000	Short term
11. Scrape and paint all exterior wood.	\$23,000-28,000	Short term
12. Alternatively, replace all wood siding on building and tower with vinyl board & batten siding.	\$25,000-30,000	Short term

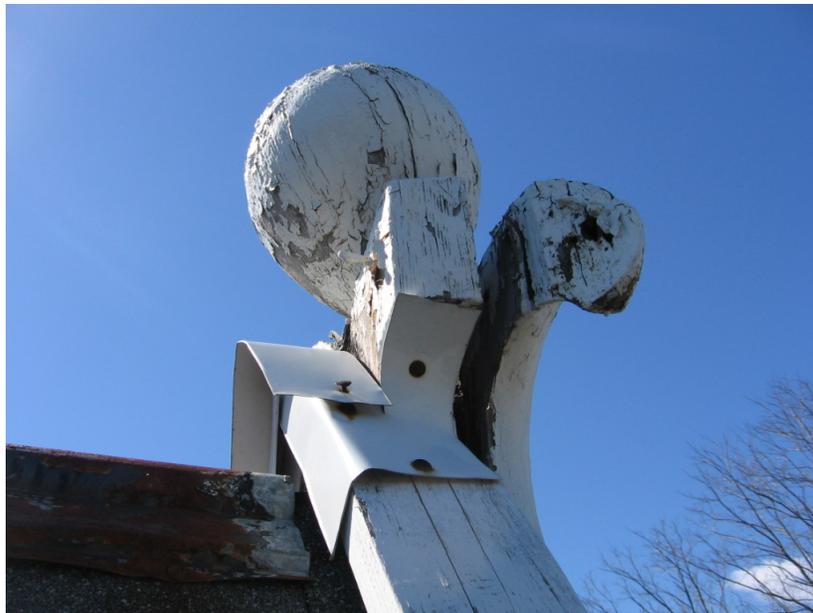
the bell level both seem to be functioning well, it is likely that water is entering through the boards themselves. As boards get wet and loosen, more water can infiltrate the towers and cause additional damage. Restoration of the tower will prevent further deterioration and water damage.

Delaminating Wood Ornament

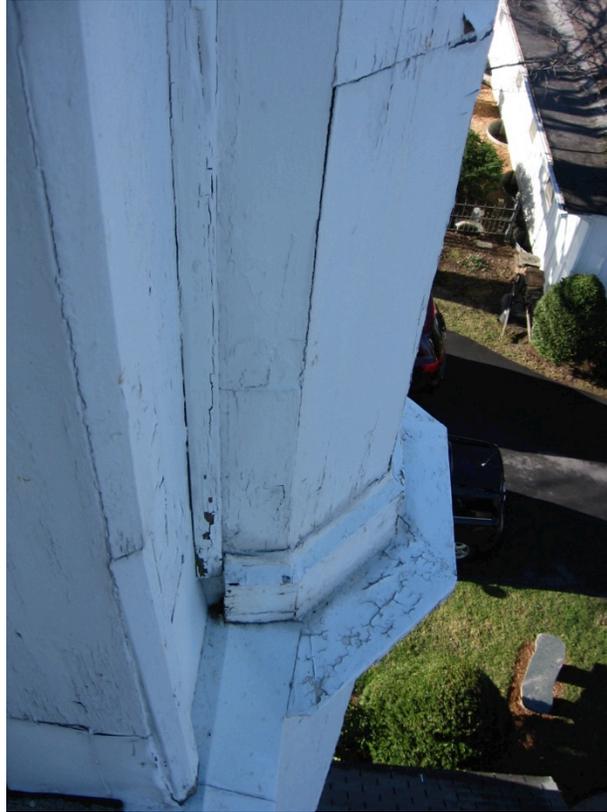
Close-up of Wood Column on Bell Tower

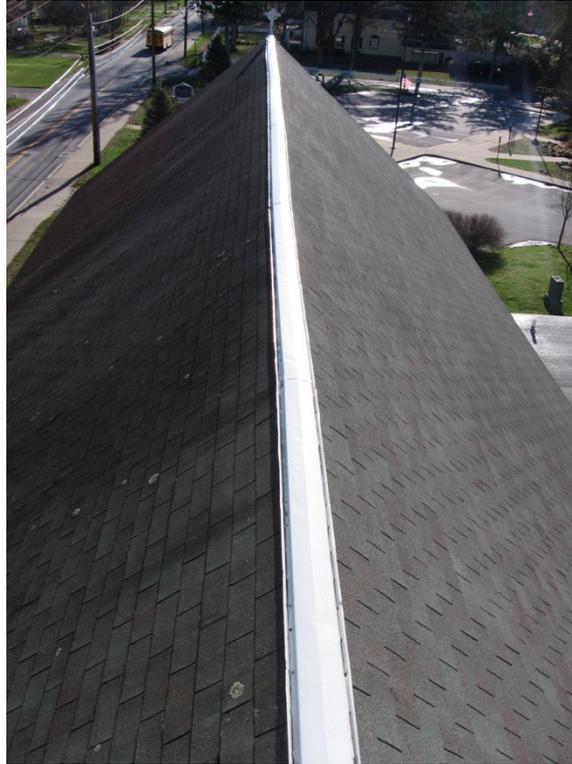
Overall View of Roof Area 1

Area 1: The largest roof is the roof covering the Sanctuary. Its age is unknown. It consists of asphalt shingles and a residential grade metal ridge vent. Missing shingles indicate the start of failure of this roof.

Recommendations	Costs	Time Frame
1. Replace roof areas 1, 2, 3 & 5 with new asphalt shingles. Replace rotted sheathing on roof area 3.	\$35,000-40,000	Short term
2. Replace roof area 4 with new rolled roofing	\$2,000-2,500	Unpredictable
3. Replace hatch in roof area 7	\$1,000-2,000	Short term

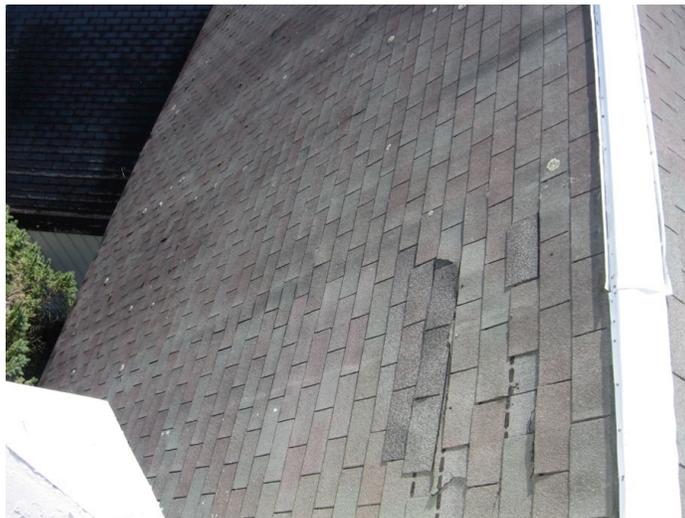
Missing Shingles in Roof Area 1

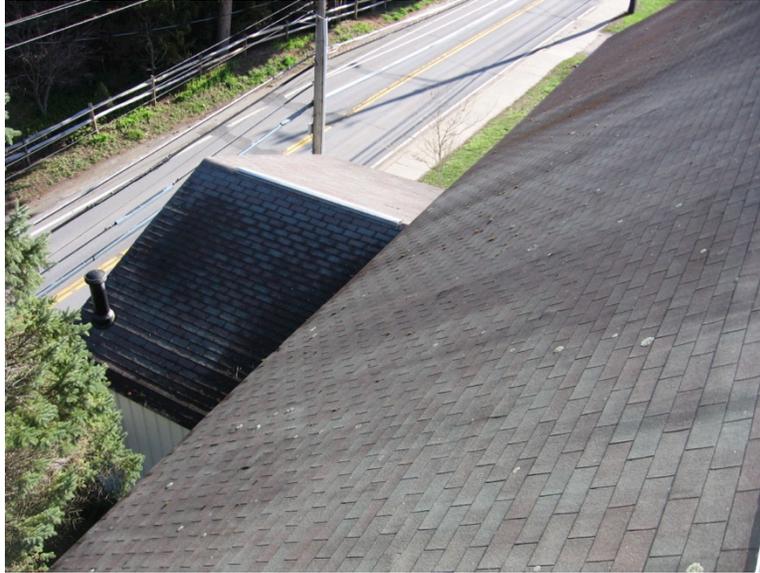
Overall View of Roof Area 2

Area 2: The north transept roof consists of asphalt shingles and a residential grade metal ridge vent. It appears to be of the same age as the Sanctuary roof and should be replaced at the same time as the Sanctuary roof.

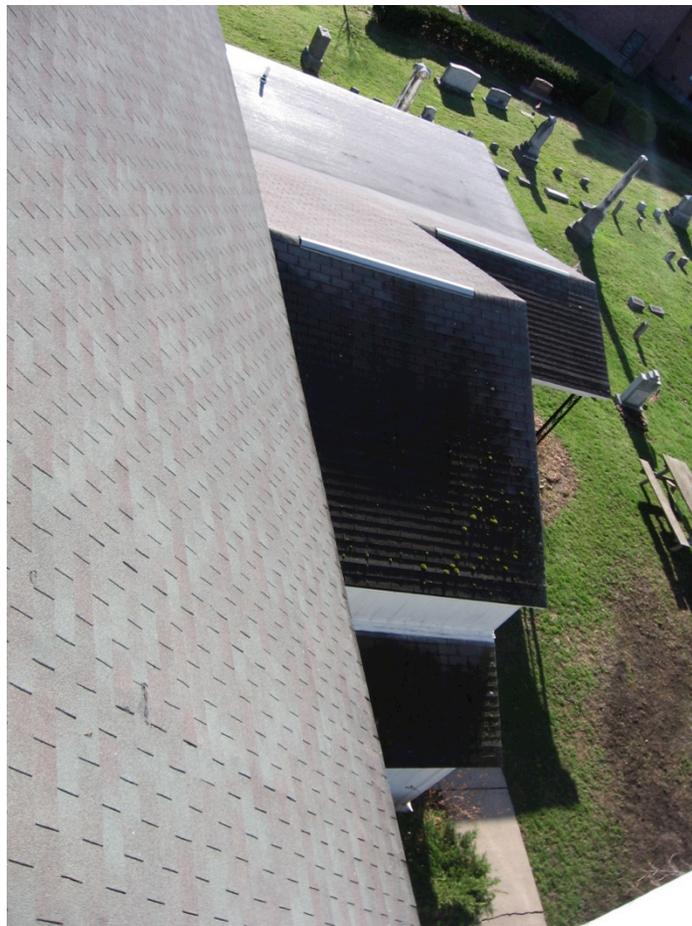
Overall View of Roof Areas 3 and 4

Area 3: The south transept roof consists of asphalt shingles and a residential grade metal ridge vent. The west side of the roof has significant vegetation growth on it. It appears to be of the same age as the Sanctuary roof and should be replaced at the same time as the Sanctuary roof. The venting pipes from the furnaces penetrate the lower portion of this roof, near the eave of the roof above. The flashing on these pipes seems to have failed a long time ago and significant damage has occurred to the plywood roof deck. This water eventually finds itself on the basement floor via the basement stair below this roof.

Area 4: On the east side of the south transept is a small area of flat roof, which is covered with rolled roofing. Drainage is off the edge to the east. There was standing water along the east edge but no signs of failure.

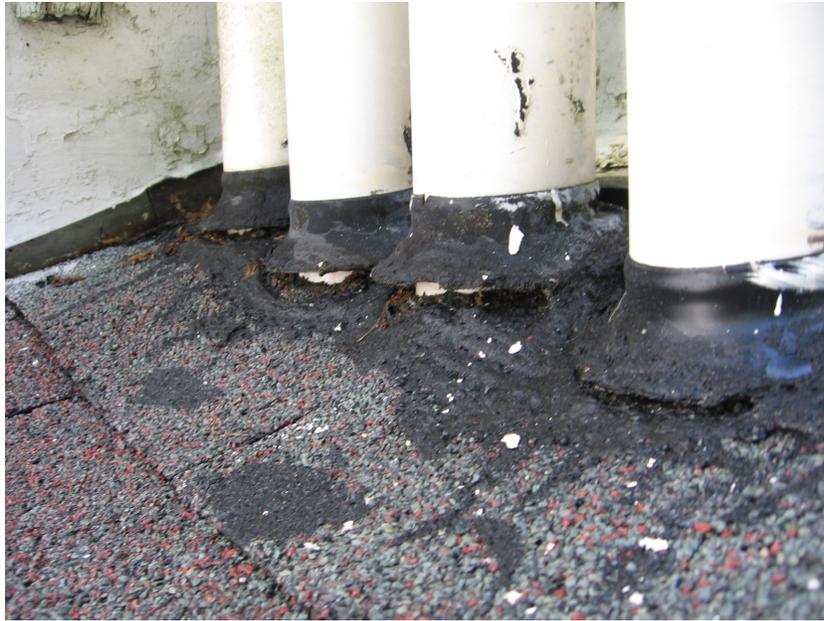
Failed Pipe Flashing in Lower Portion of Roof 3

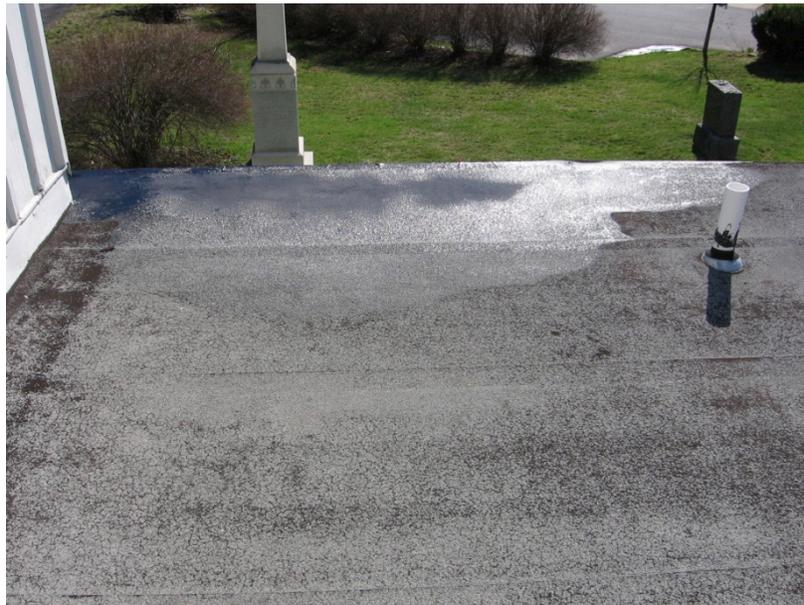
Standing Water on Roof Area 4

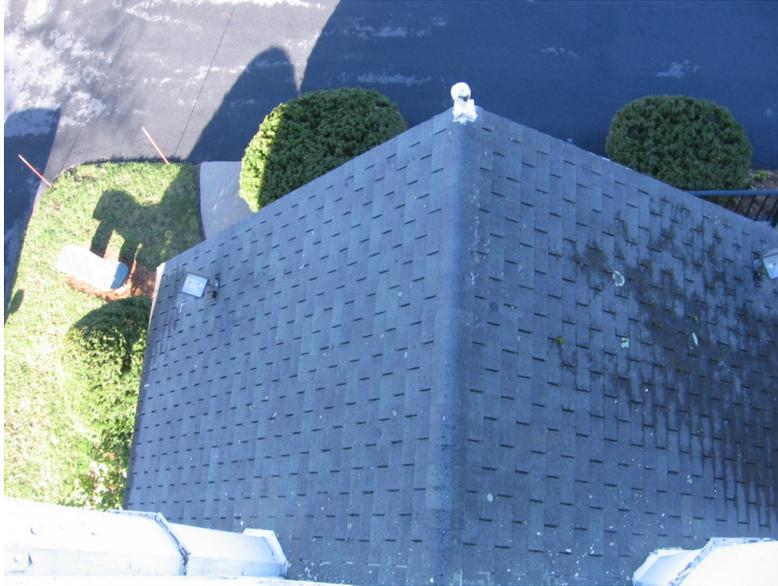
Overall View of Roof Area 5

Area 5: The Narthex roof consists of asphalt shingles and an asphalt shingle ridge cap. It is penetrated by one ornamental feature and by two light fixtures that illuminate the face of the tower. It is also showing signs of age and replacement should be considered.

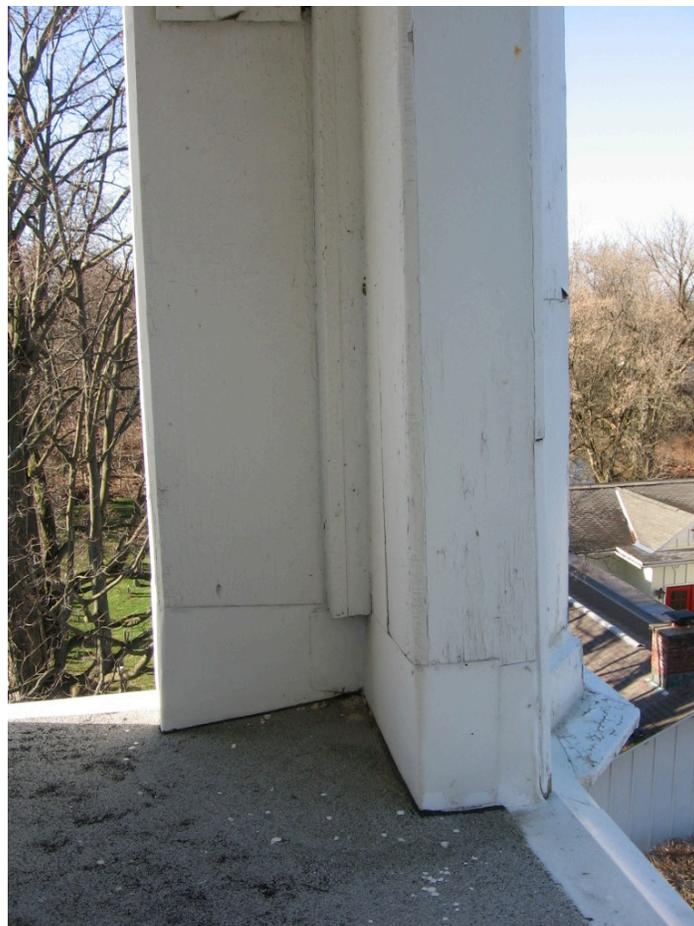
Detail of Roof Area 6 at Corner

Area 6: At the level of the bell in the bell tower is a flat roof, which is covered with rolled roofing and penetrated by a hatch and copper tubes serving as sleeves for the bell ropes. The bell cradle sits on top of this roof. The roof drains to the edges and appears to be in good condition.

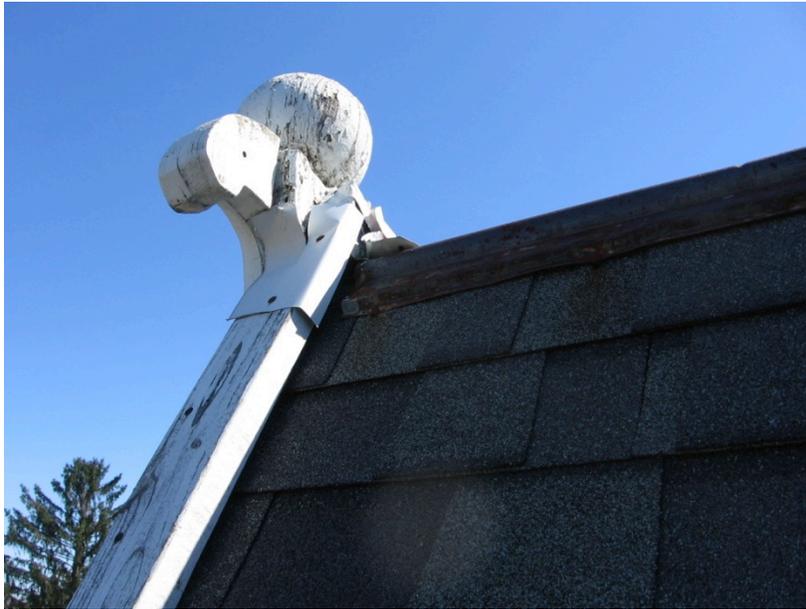
Detail of Roof Area 7

Area 7: The roof of the bell tower consists of asphalt shingles with a metal ridge cap. There is a hatch in the northwest quadrant of the roof, from which we could inspect that area of the roof. The roof and ridge cap appeared to be in good condition; however, the wood cap at the edge of the roof was coming loose. The hatch has no permanent attachment to the roof and is difficult to open & close.

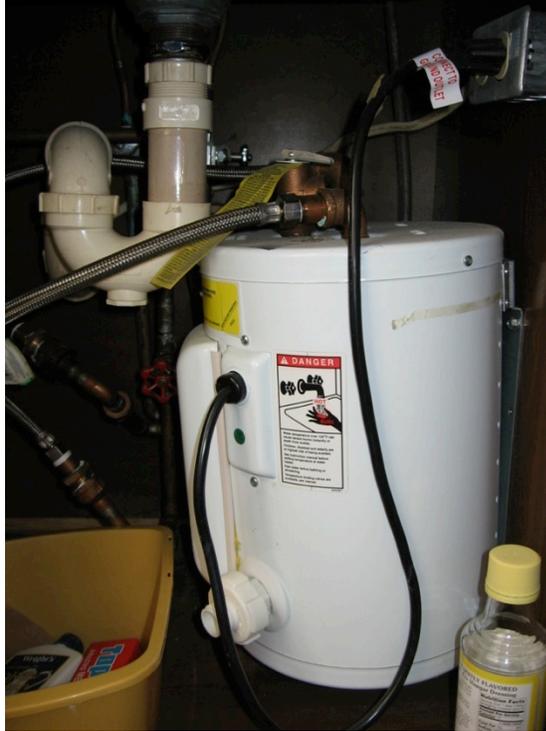
Domestic Water Heater

- Domestic Hot Water Production: Rheem 2.5 gallon electric water heater, located under the Sacristy sink. A six year warranty is provided; however, date of installation is unknown but is assumed to be within the past ten years. While it is impossible to predict with certainty when a domestic water heater will fail, these units typically last 10 years so it may soon exceed its useful life.

Recommendations	Costs	Time Frame
1. Replace domestic water heater	\$1,000	Unpredictable
2. Replace HVAC equipment	\$15,000-18,000	Unpredictable
3. Provide a lightning protection system	\$7,500-15,000	Unpredictable

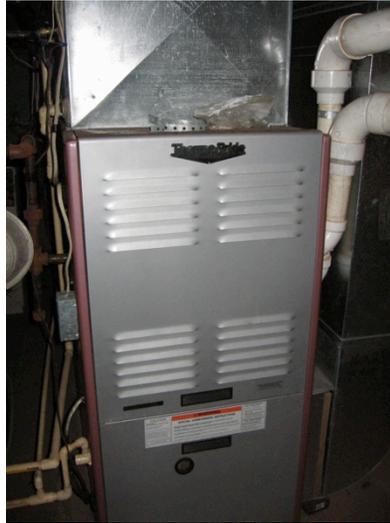
Equipment

- Type: There are two gas-fired ThermoPride condensing furnaces located in the basement that provide both heating and cooling to the building.

- Distribution System: Forced air, sheet metal ductwork, not insulated.
- Age: The units were installed in 1997, which would make both the furnaces and condensing units sixteen years old. While it is impossible to predict with certainty when these units will fail, the average life for this type of system is 15-20 years.
- Past Inspections & Repairs: According to labels on the furnaces, they were last inspected in October 2007 and last repaired in October 2009, when a blocked intake was cleared of leaves.
- Furnace Controls: A programmable thermostat is located in the Sanctuary, near the chancel.
- Operating/Shutdown: During our inspection the heating equipment appeared to be operating.

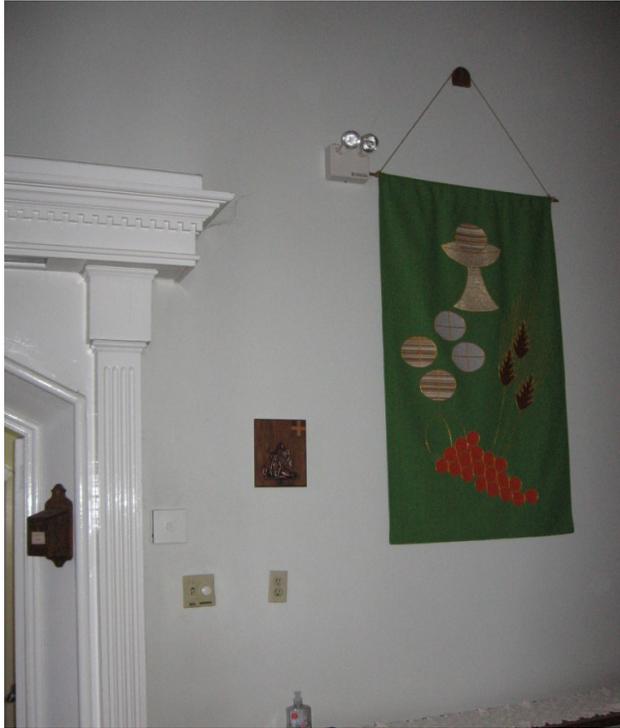
Emergency Light in Sanctuary

Emergency Lighting: One emergency lighting fixture was observed in the Sanctuary.

Recommendations	Costs	Time Frame
1. Provide emergency exit lighting throughout building per code	\$1,500-2,000	Short term
2. Provide illuminated exit signs at building exits	\$1,500-2,000	Short term
