# Property Condition Assessment

55 Main Street, Lenox, MA

**Inspection Date:** Sept. 14, 2020

**Inspected by:** Foresight Architects  
434 State Street, Schenectady, NY 12305  
Inspector: James Hundt, RA  
Phone: (518) 339-3158

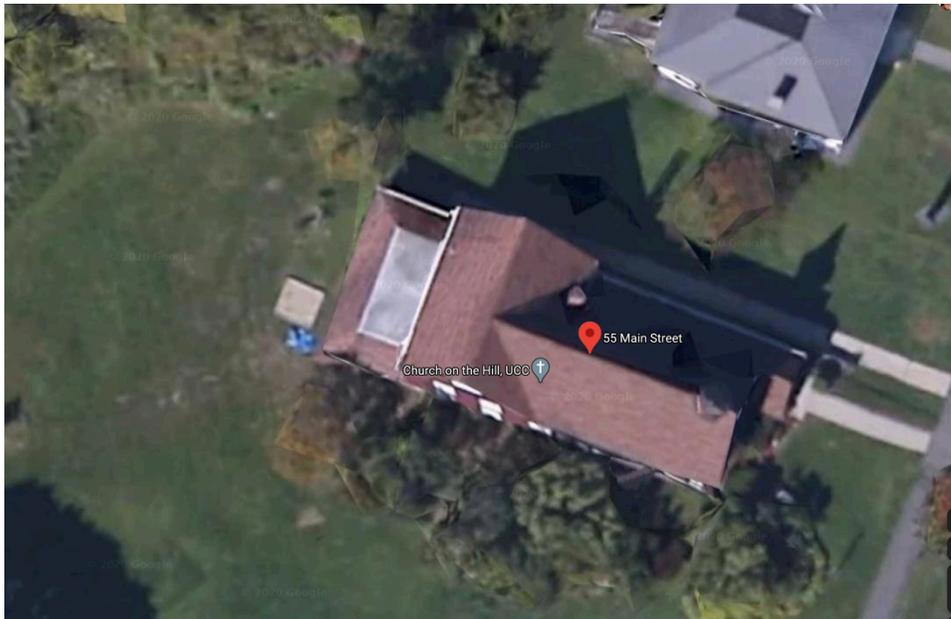
Site

Topography: The building is set into a slope, making both the First Floor and Basement accessible from grade. The First Floor is elevated above the public sidewalk. The grade gradually slopes down along the sides of the building to the rear. Access from grade to the Basement is by way of side doors located just before the one-story basement addition. There are bluestone retaining walls at both sides of the building entry, with the one on the north side curving toward the street. These walls are in very good condition. The one on the north side needs minor repointing at the top course.

Storm Water System: Drainage from the sloped roofs is handled by gutters and downspouts. There are (3) downspouts on the north side. Two of the downspouts discharge water on grade while a third downspout is connected to a rain barrel. There is only one downspout on the south side, which terminates below grade. According to the sexton, this downspout is connected to a drywell at the rear of the building. This work was done less than ten years ago. Other than a crushed downspout extension at the northeast corner of the building, this system seems to be functioning properly and is helping keep stormwater runoff away from the building foundation.

Recommendations	Costs	Time Frame
Repoint top portion of north retaining wall	<\$3,000	Immediate
Replace crushed downspout extension	<\$3,000	Immediate
Repair ramp & replace handrail	\$7,500	Short-term
Remove fuel oil tank	<\$3,000	Short-term
Remove sand from back yard	<\$3,000	Short-term

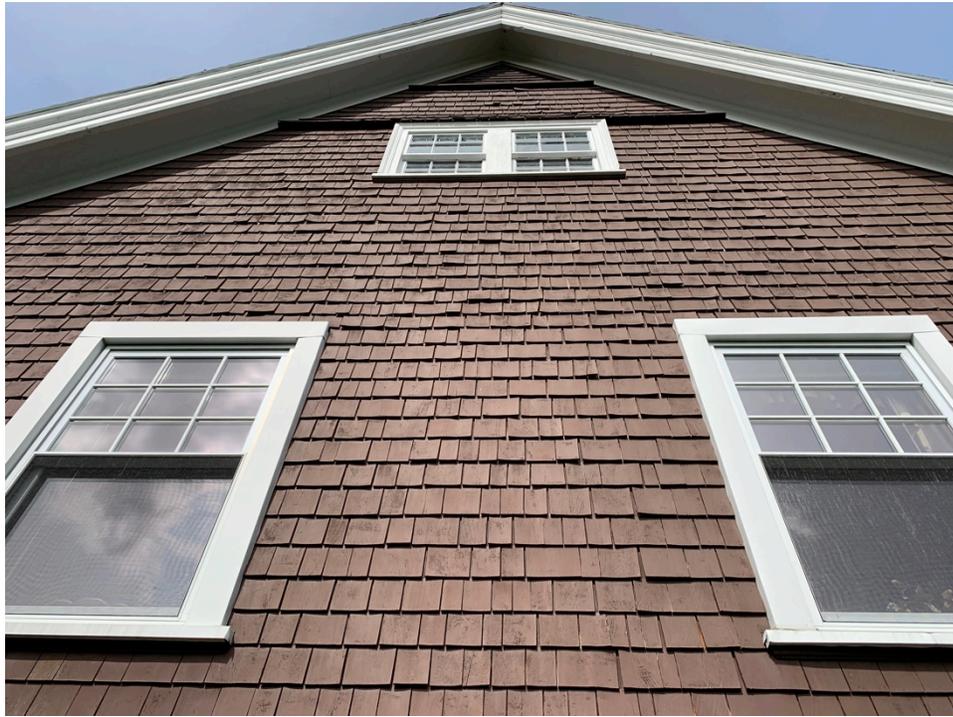
- **Sidewall System:** Almost the entire building, including the octagonal bell tower, is covered with painted wood shakes. Many of the shakes on the lower portion of the south side have recently been replaced. Additional shakes on the south side – particularly those on the gabled portion - may need replacement in the future, as they are showing some cupping and splitting. The remainder of the

shakes appear to be in good condition. The walls surrounding the front door of the building have board siding above a wood shake knee wall. The boards and trim could use repainting.

Aging Shakes on South Façade

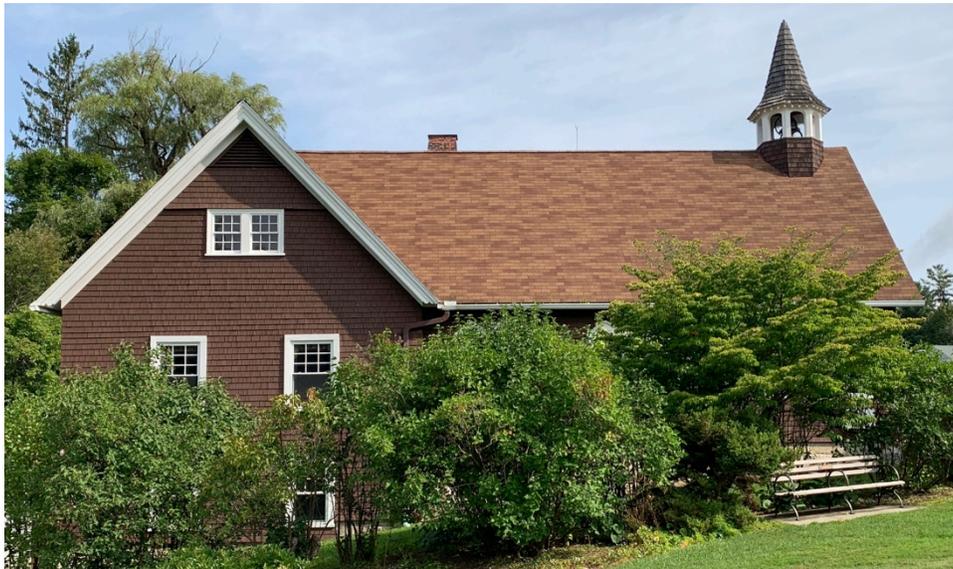
Drainage: Portions of the roof are provided with gutters that appear to have some kind of cover on them. There is plant growth in the gutter on the south side of the main roof that should be removed to keep the gutters working properly.

Overall View of Roof

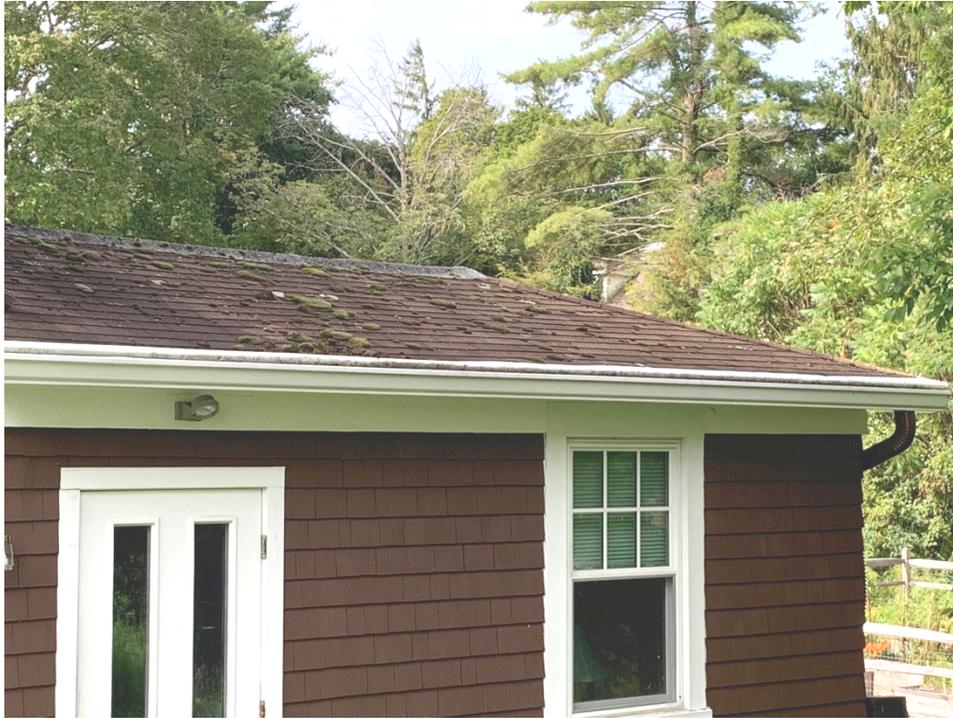
Area 4: These are the three sloped roofs adjacent to the flat roof. The portion on the north side has significant algae growth and should be cleaned to prevent further growth. The other two sides appear to be in good condition.

Algae Growth on North Roof

Recommendations	Costs	Time Frame
Clean roofs over addition with algae growth	<\$3,000	Immediate
Remove plant growth from gutter on south side	<\$3,000	Immediate

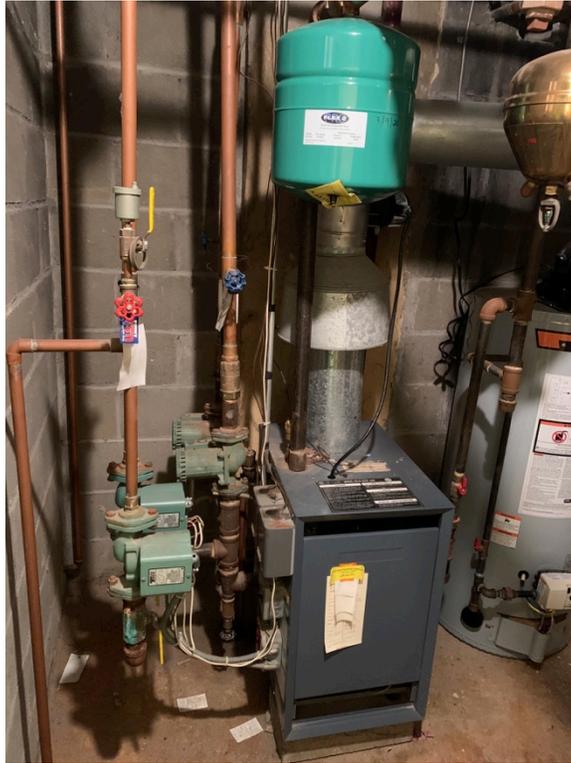
Equipment

- Type: Gas. There is one Weil-McLain boiler located in the Boiler Room. Specific information about the equipment is limited, as electrical boxes had been installed over the nameplates. It appears that it has a 117,000 Btu/hr. capacity and a model number of CG-5-SPDN.

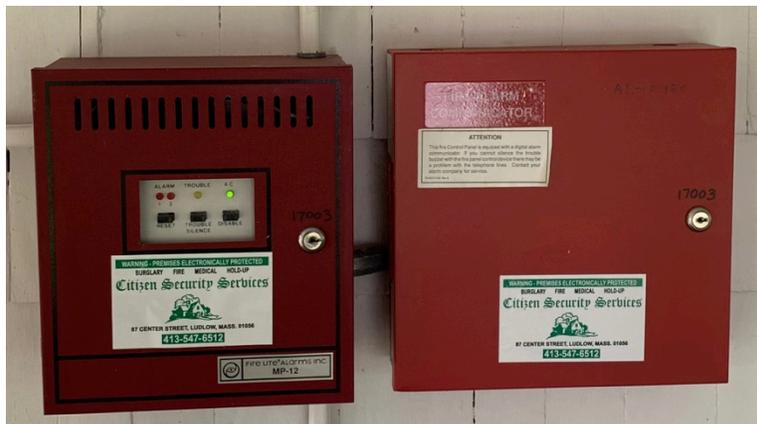
Fire Alarm Panel

**Fire Alarm Systems:** The existing system consists of a main panel and annunciator in the passageway on the First Floor. The building is equipped with pull boxes at all the exits.

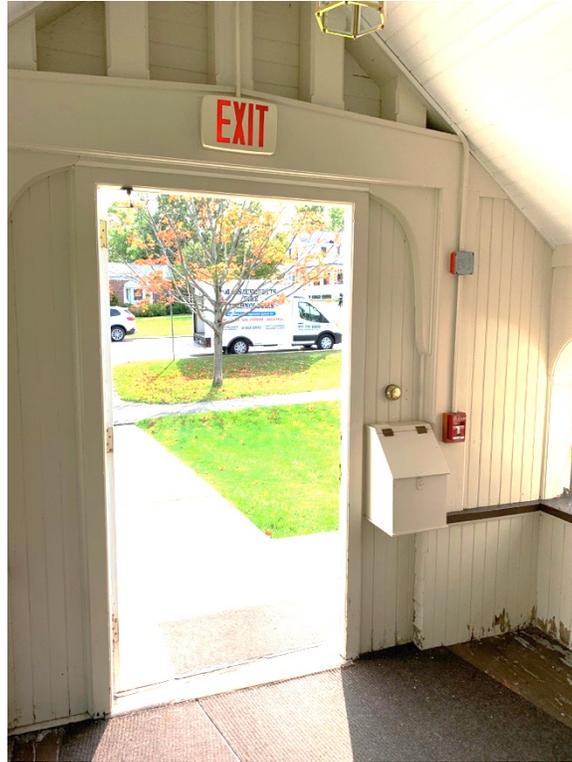
Front Entry

- Wall Finishes: Plaster with wood wainscoting throughout except in the offices, where the interior partitions are gypsum board, and in the Parlor and the entry area to that room, where there is no wainscoting. The passageway has painted wood shakes on the interior wall. Some of the beadboard wainscoting in that space (near the main entry door) requires repainting.

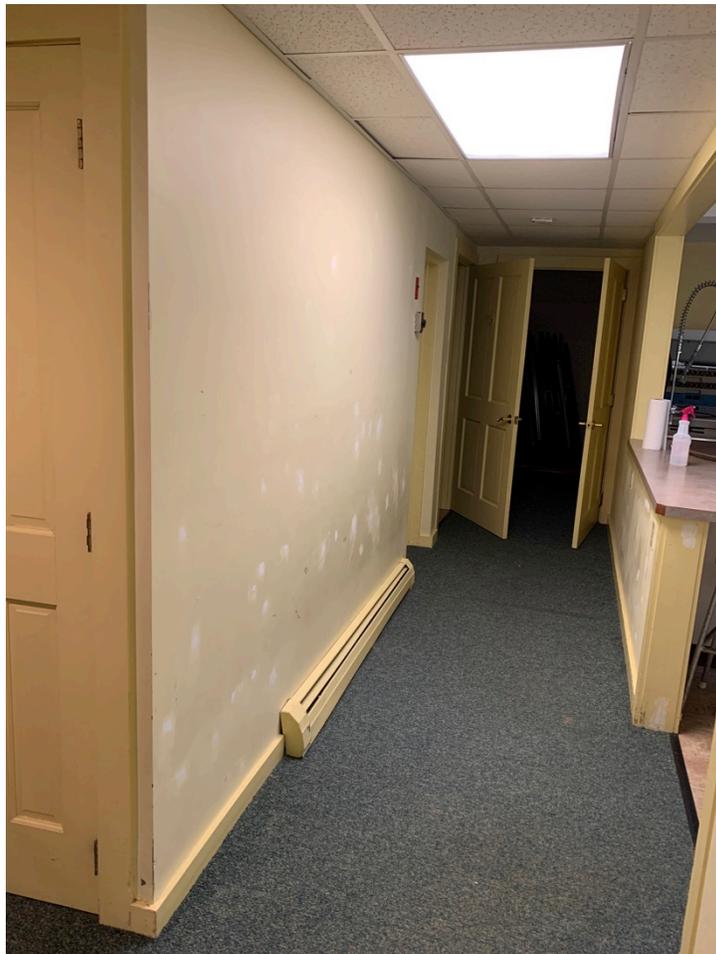
Basement Hallway

- Wall Finishes: Wall finishes throughout the basement are drywall, with the addition of beaded plywood wainscoting in the Dining Room. There are numerous corkboards in the Dining Room and the hallway to the Kitchen. These should either be removed or repainted, as the multiple pinholes detract from the appearance of the wall finishes. The north wall of the Hallway needs to be sanded and repainted.

Recommendations	Costs	Time Frame
Sand & repaint patched walls in Basement hall	<\$3,000	Short-term
Replace carpet with appropriate floor covering	\$7,500	Short-term
Adjust office closet door to close properly	<\$3,000	Short-term
Repair or replace Basement level interior doors	\$6,000	Short-term
Remove or repaint cork bulletin boards	<\$3,000	Short-term
