Property Condition Assessment

85 Lake Hill Road
Burnt Hills, NY

Inspection Date: April 17, 2013

Inspected by: Foresight Architects
426 State Street, Schenectady, NY 12305
Inspectors: James Hundt, RA & Ted Lutz, RA
Phone: (518) 372-3655

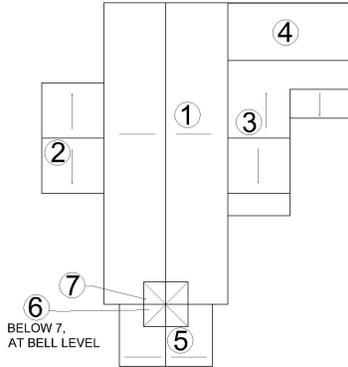
Roof Plan

Area 1: The largest roof is the roof covering the Sanctuary. Its age is unknown. It consists of asphalt shingles and a residential grade metal ridge vent. Missing shingles indicate the start of failure of this roof.

9. Replace roof areas 1, 2, 3 & 5 with new asphalt shingles. Replace rotted sheathing on roof area 3.	3.4	\$35,000-40,000
10. Replace hatch in roof area 7	3.4	\$1,000-2,000

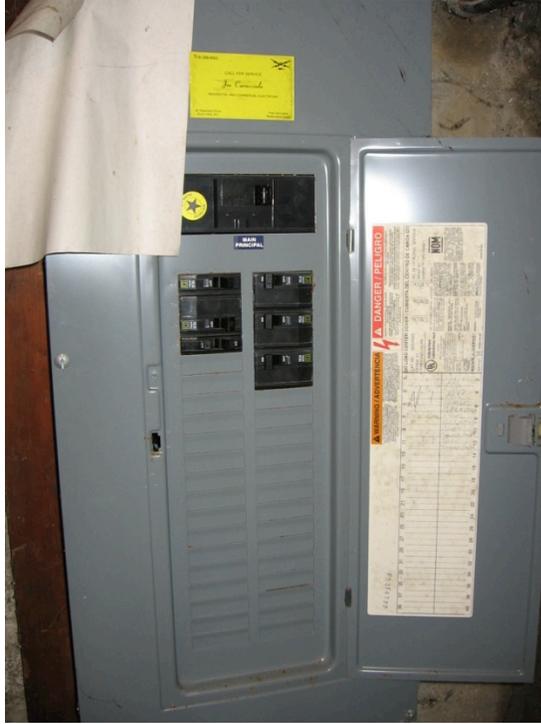
Main Service Panel

- Service and Metering: The electric service is 200 amps. The capacity was determined by the rating of the main disconnect switch in the crawlspace near the basement. This service should be adequate for the present usage.

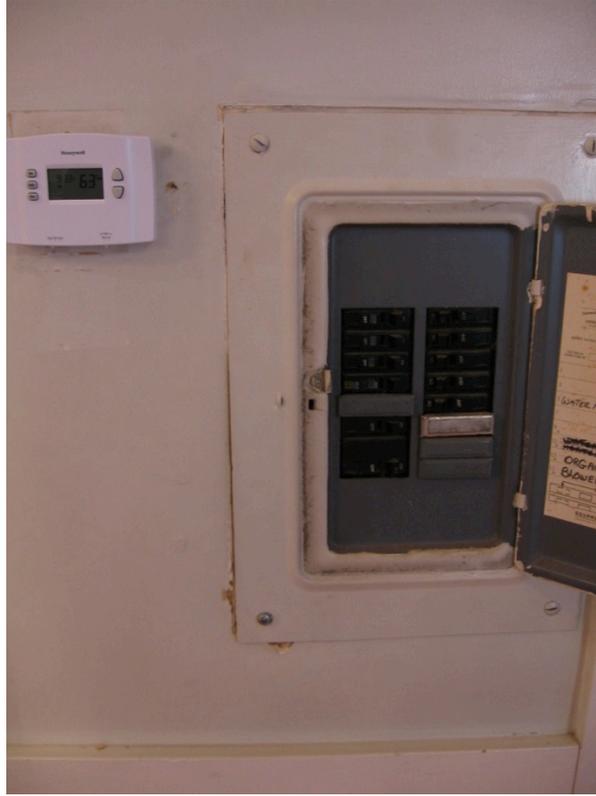
Distribution Panel and Programmable Thermostat

- Distribution Panels: There are two circuit breaker panels located on the first floor. One is located near the thermostat and the other is located in the Narthex.

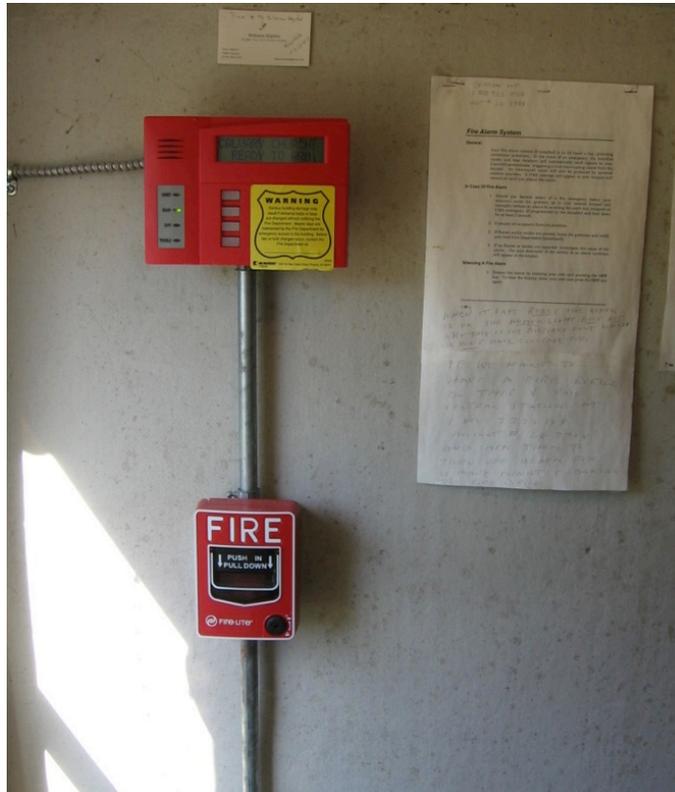
Fire Alarm Panel

Fire Alarm Systems: There is a fire alarm panel located near the door to the basement stair.
