# Property Condition Assessment

55 Main Street, Lenox, MA

**Inspection Date:** Sept. 14, 2020

**Inspected by:** Foresight Architects  
434 State Street, Schenectady, NY 12305  
Inspector: James Hundt, RA  
Phone: (518) 339-3158

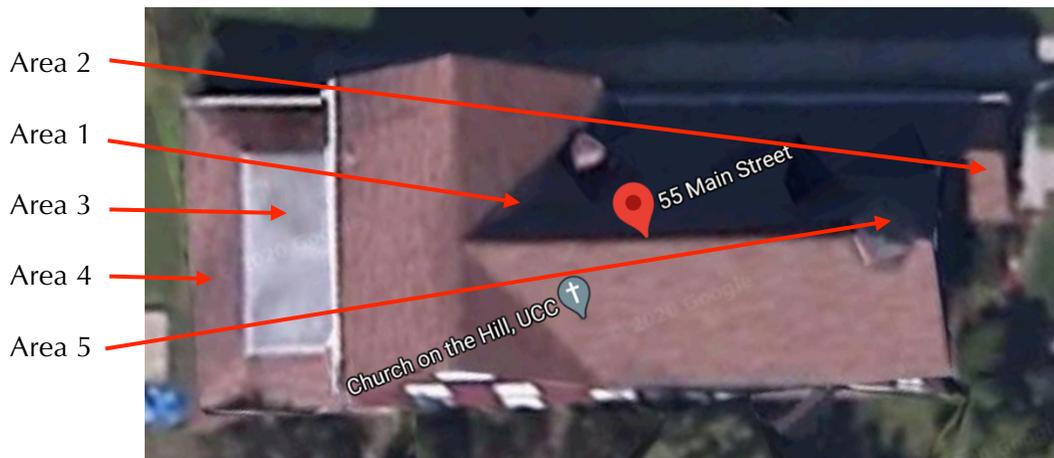
Google Image of Roofs

Area 1: This describes the sloped roof that covers the majority of the building. It consists of a steeply pitched gable roof running east-west that is intersected on the west end with another gable roof of the same pitch running north-south. Along the north side of the building, the roof pitch decreases over the passageway. This roof includes two closed valleys and appears to be in good condition. There are stains in the ceiling below the bell tower that indicate the possibility of leakage but we were told that these stains are from a leak that has been previously repaired and that there are no current leaks.
